Davis-Besse Reactor Pressure Vessel Head Degradation

Overview, Lessons Learned, and NRC Actions Based on Lessons Learned

NUREG/BR-0353, Rev. 1
August 2008

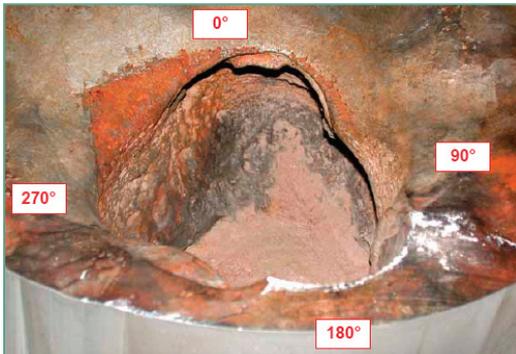
Figure 4a. Close-up view of the cavity
