Davis-Besse Reactor Pressure Vessel Head Degradation

Overview, Lessons Learned, and NRC Actions Based on Lessons Learned

NUREG/BR-0353, Rev. 1
August 2008

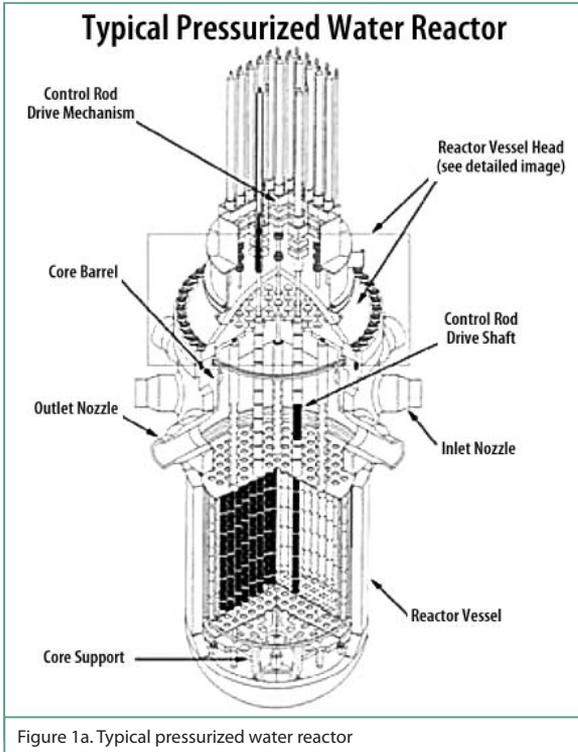
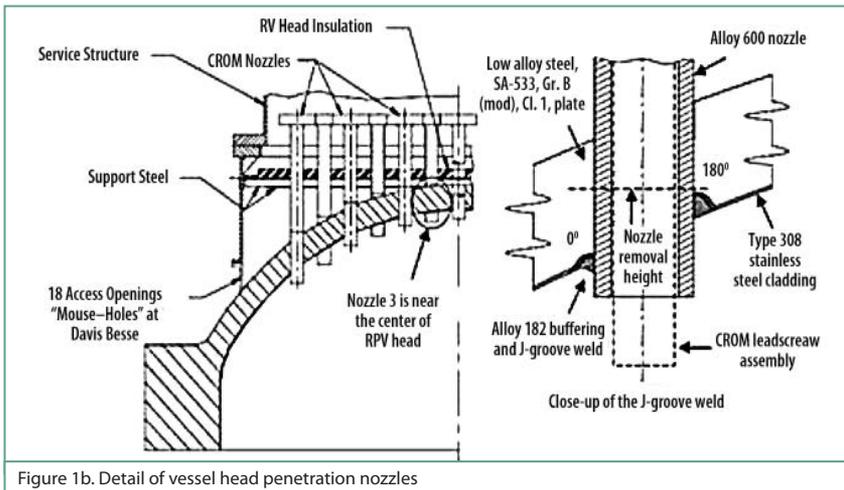
The repair of these nozzles was performed remotely from underneath the head. On March 6, 2002, the licensee terminated the repair process on CRDM nozzle 3 to determine the cause of unusual equipment operation, and removed the machining apparatus from the nozzle. During the removal, the nozzle tipped in the downhill direction until it rested against an adjacent CRDM. If structurally sound, the surrounding steel should have held the nozzle in place.

The licensee investigated the condition of the RPV head surrounding CRDM nozzle 3. The investigation included removing the CRDM nozzle and removing boric acid deposits from the top of the RPV head. Upon completing the boric acid removal on March 7, 2002, the licensee conducted a visual examination of the area and identified a large cavity in the RPV head on the downhill side of CRDM nozzle 3 (**Figure 2**). The corrosion was caused by borated water that leaked from the reactor coolant system onto the vessel head (**Figures 3 and 4**) through cracks in the nozzle and the weld that attached nozzle 3 to the RPV head (**Figures 5 and 6**). The remaining thickness of the RPV head in the wastage area was found to be approximately 3/8 inch. This thickness consisted of the thickness of the stainless steel cladding on the inside surface of the RPV head, which is nominally 3/8 inch thick. The stainless steel cladding is resistant to corrosion by boric acid, but it is not intended to provide structural integrity to the vessel. Failure of the stainless steel cladding would have resulted in a loss-of-coolant accident (LOCA). The LOCA would have resulted in actuation of the plant's emergency systems.
